**Special Inspection**

**CT-2022-0571**

Project: **POLO ENERGETICO ZARATE 23**

Shop Order No: **MB000169**

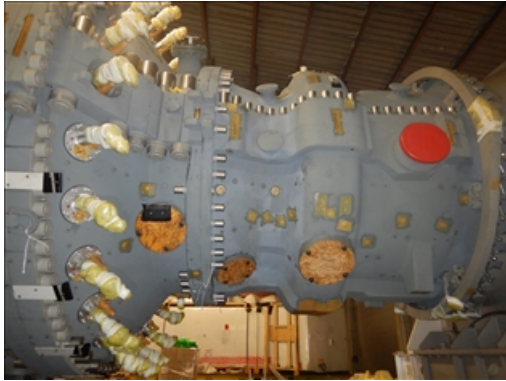
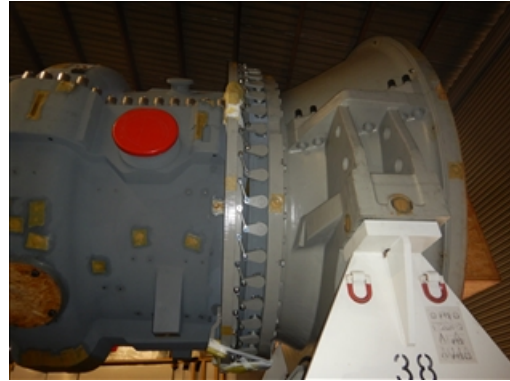
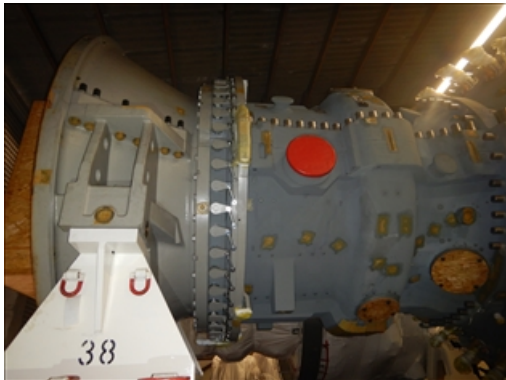
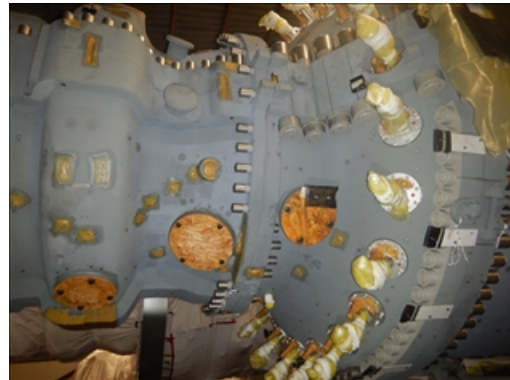
The compressor casing surface were found in good condition.

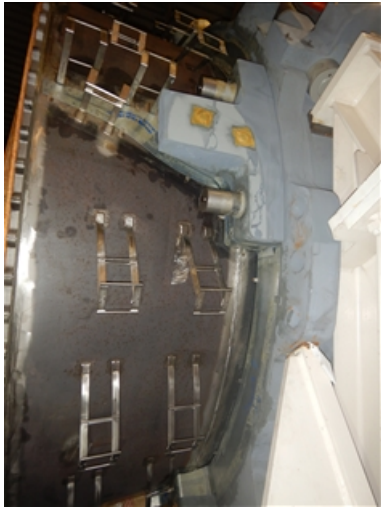
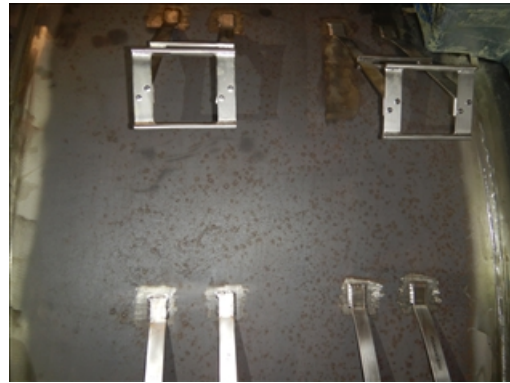
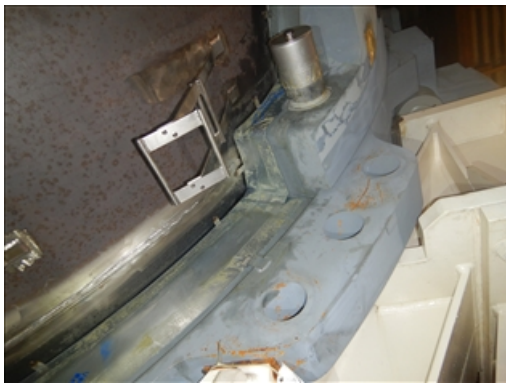
1. The turbine exit casing (TEC) was found with signs of surface corrosion on several spots.
2. One half joint bolt was found with painting loss and corrosion.

TEC (1)

The findings can be left as found.

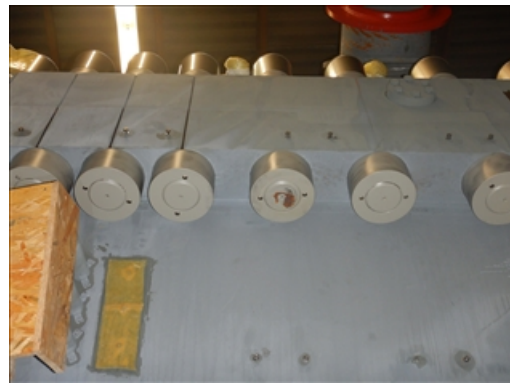
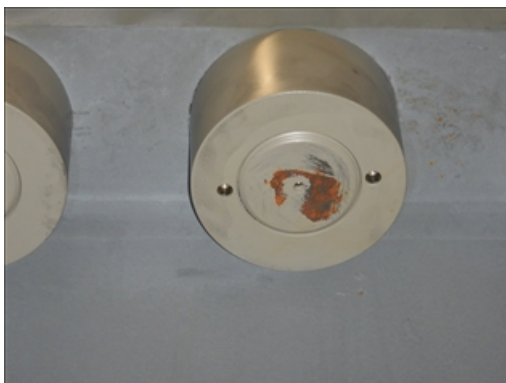
turbine side half joint bolt (1)

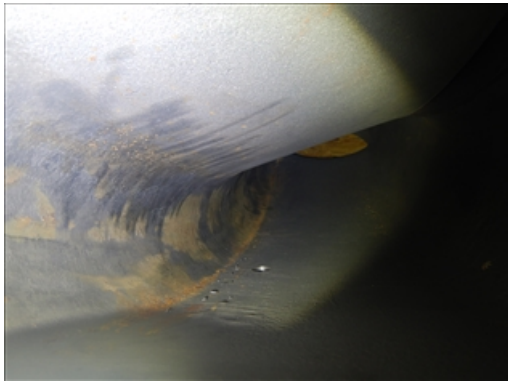
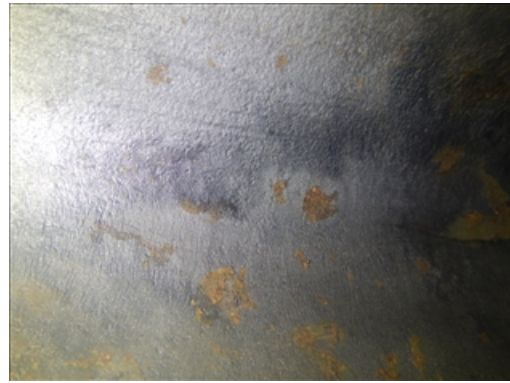
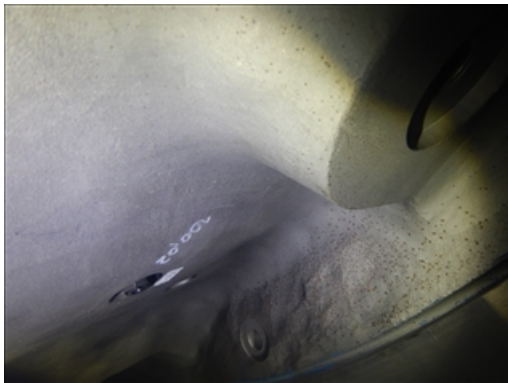
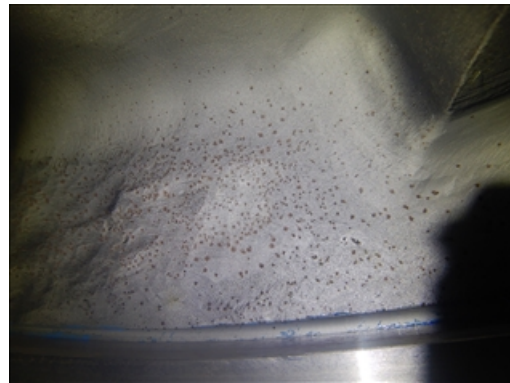
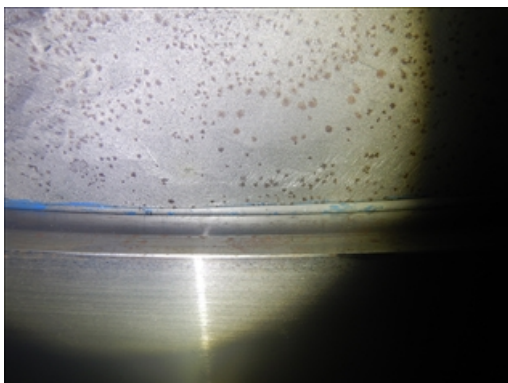
The outer surface of compressor vane carriers (CVCI and CVCII) was found with signs of corrosion.

CVCII outer surface (1)

The finding can be left as found.

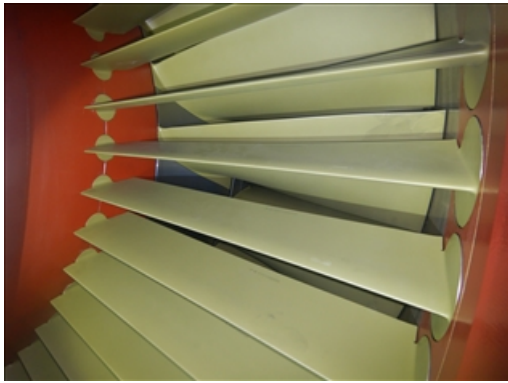
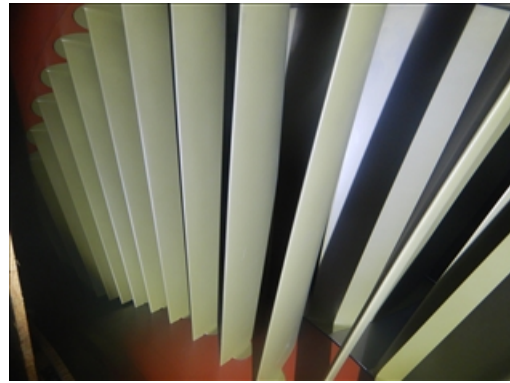
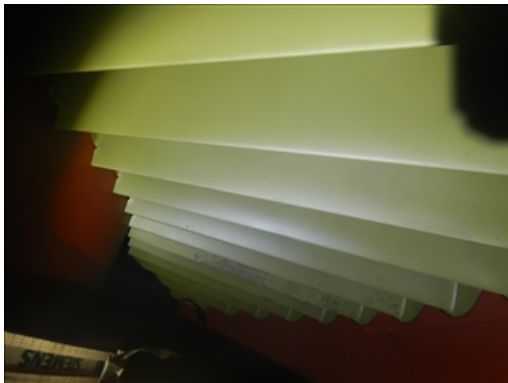
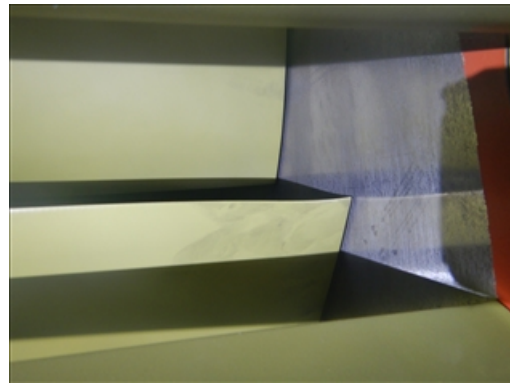
The compressor inlet area/IGV area were found in good condition - No signs of corrosion were detected.

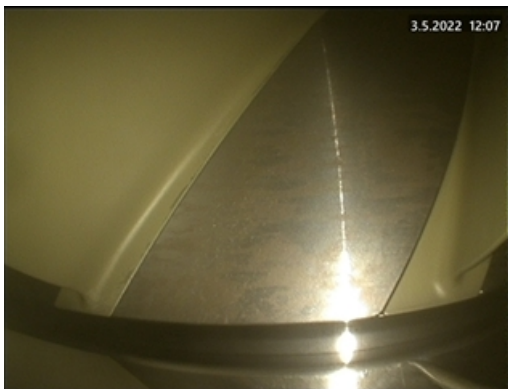
The outer ring of VLe5 and the inner ring of VLe13 show spots with signs of corrosion.

VLe5\_outer ring

The finding can be left as found.

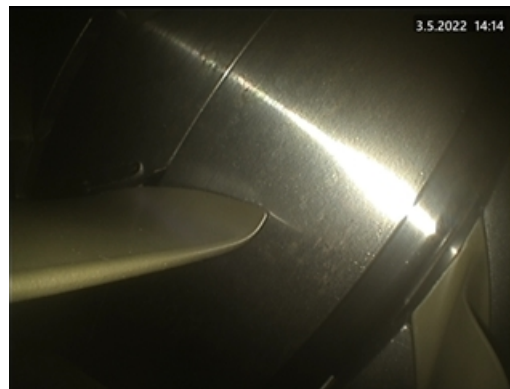
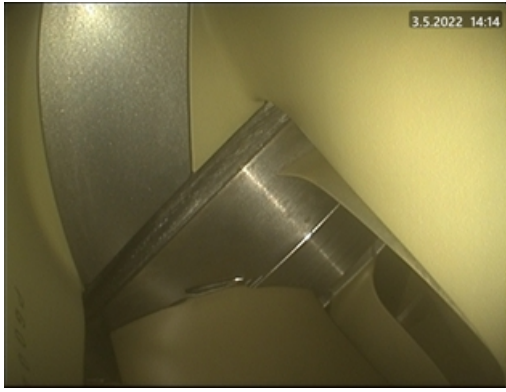
VLe13\_inner ring (1)

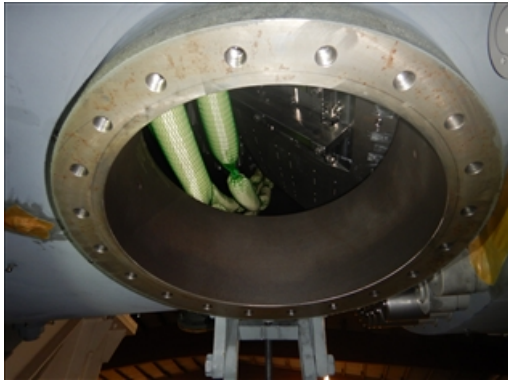
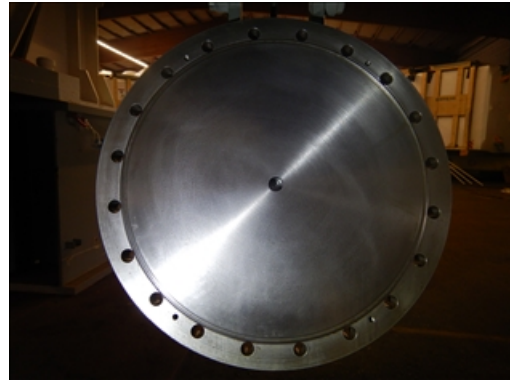
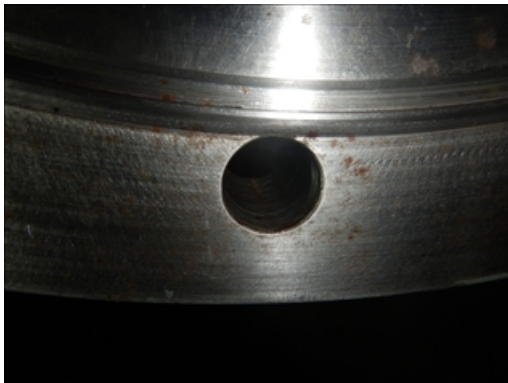
The lower outer manhole cover and the lower inner manhole connecting elements were found with corrosion.

outer manhole (1)

The findings can be left as found.

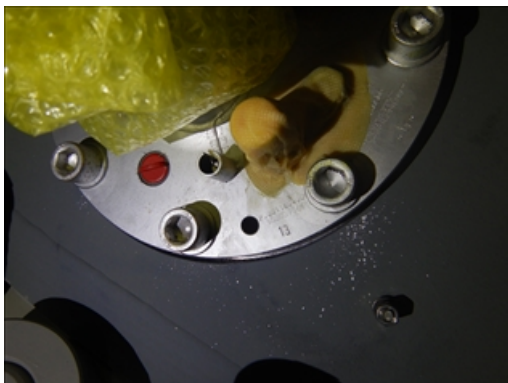
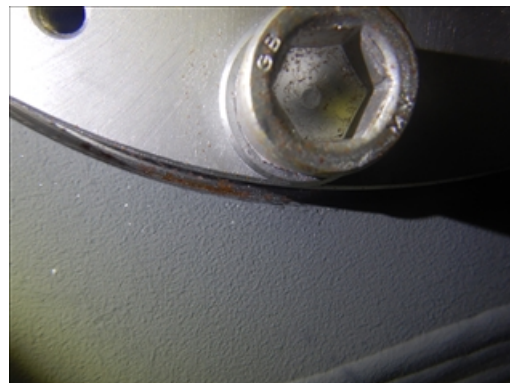
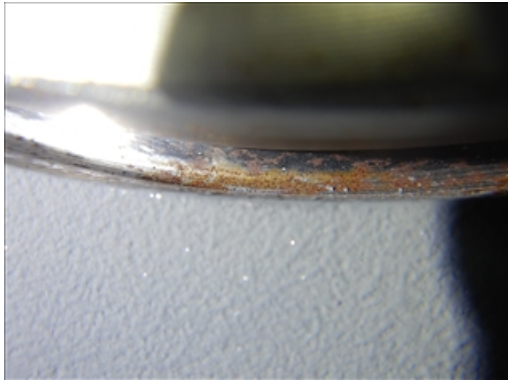
The burner supports were found with spots of corrosion on the surface and at the contact surface to casing 2.

Burner support (1)

The finding can be left as found.

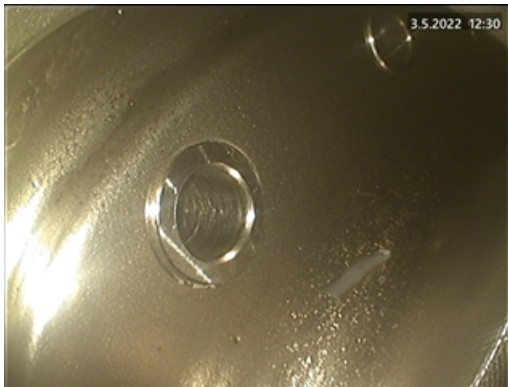
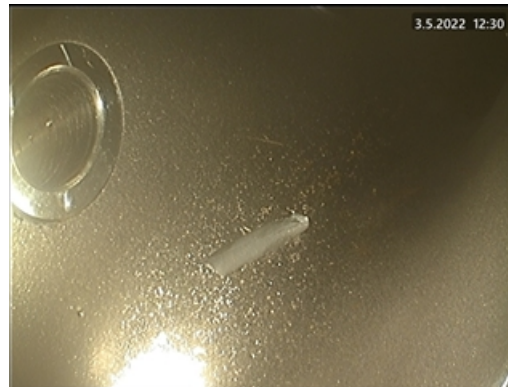
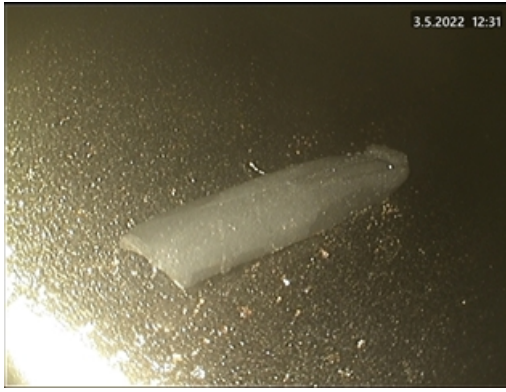
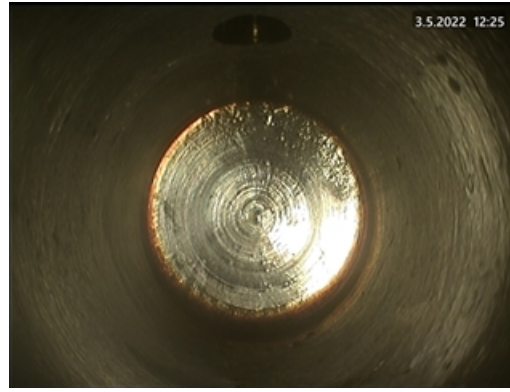
1. Both burners show brownish/reddish deposits in the vane holes. According to similar findings of MB000121, it could be assumed that the deposit here is oil either.
2. Slight corrosion in the ring channel could be observed.
3. Some loose particles (fuzz or metal chips) could be found. Burner at position #10 shows the the larger particle.

Burner #10\_inner channel (1)

After consulting with Engineering, the findings can be tolerated for the operation. To remove the particle in burner #10, the burner should be disassembled and a rinsing should be performed. The other option is to carry out a reverse blow out during commissioning.

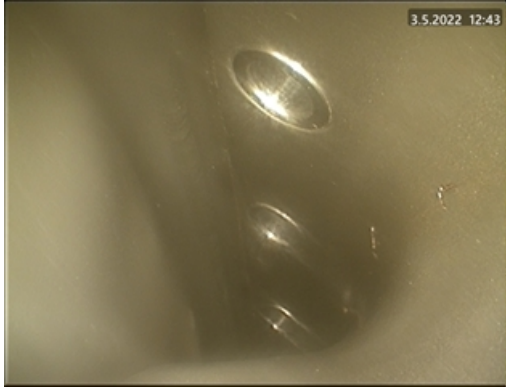
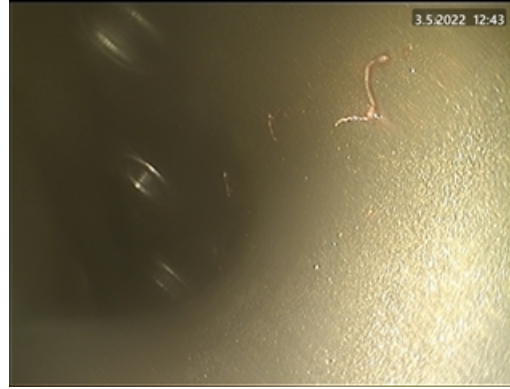
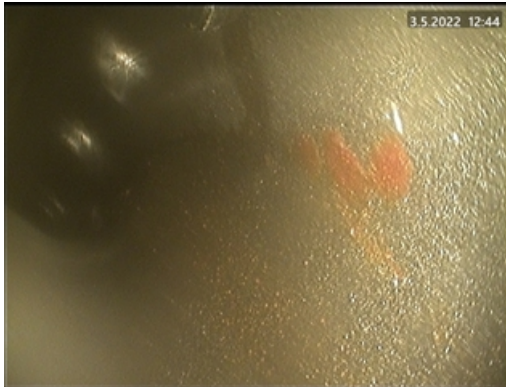
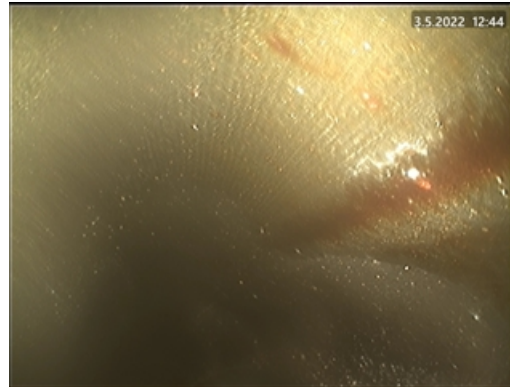
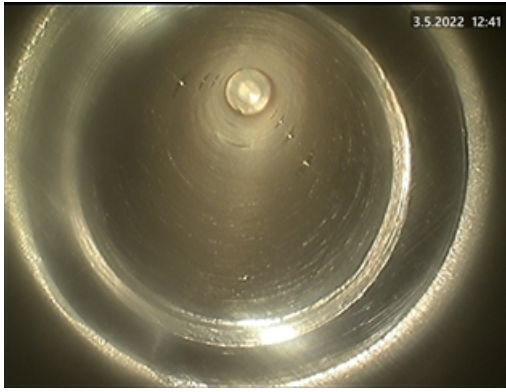
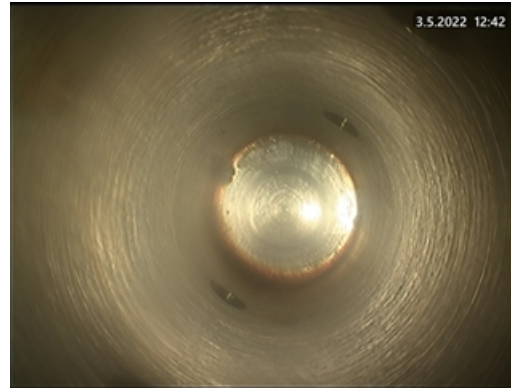
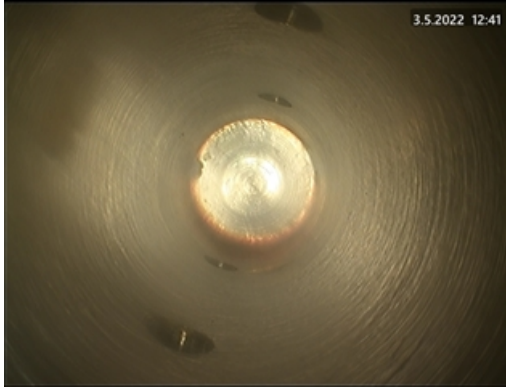
Burner #14\_ring channel (1)

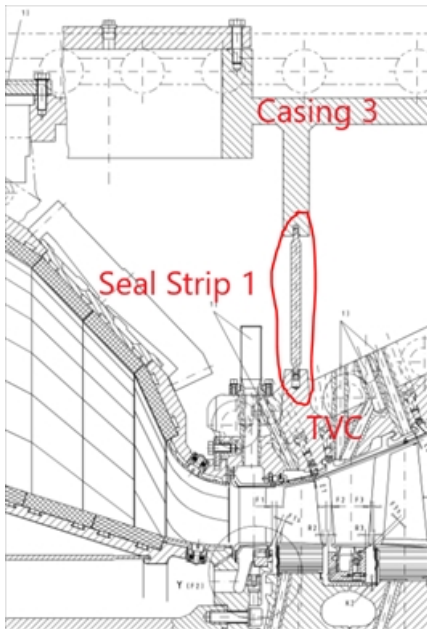
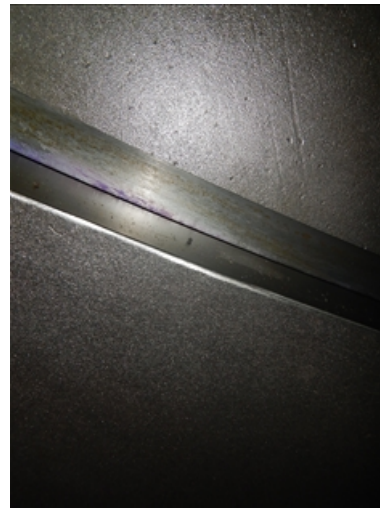
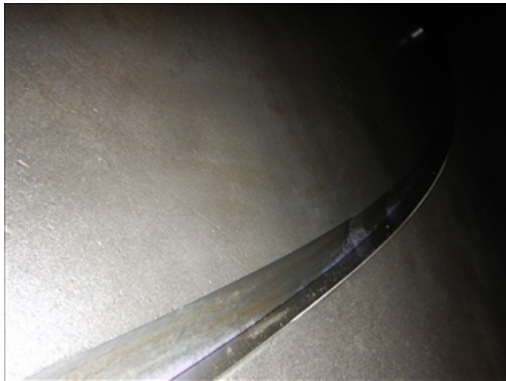
The seal strip 1 between TVC and casing 3 was found with signs of oxidation.

Seal strip 1

The finding can be left as found.
