Fact Finding Report

Special Inspection

Project: **POLO ENERGETICO ZARATE 23**
 Shop Order No: **MB000169**
 Event ID: **NA**
 Period of Time: **2024-09-02 to 2024-09-05**

CT-2024-1425

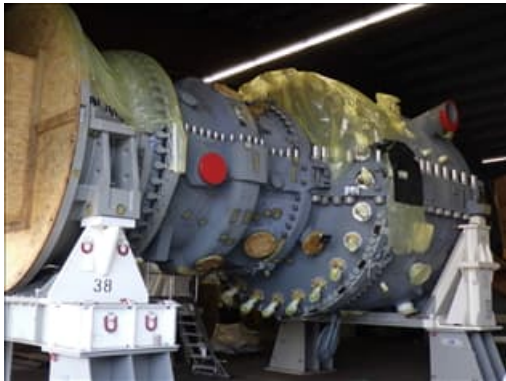
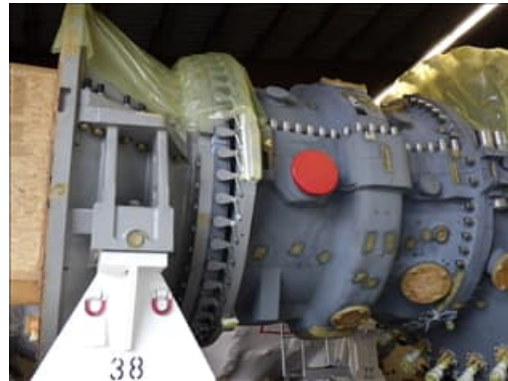
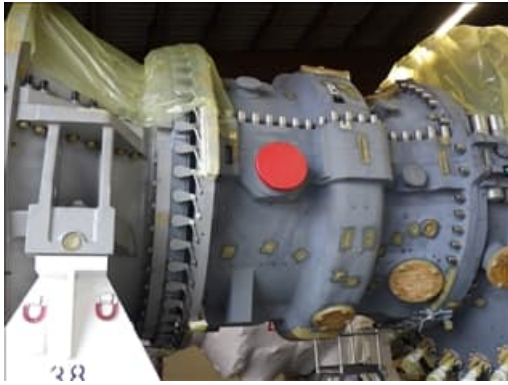
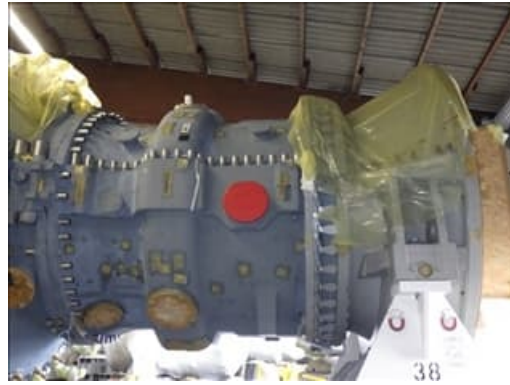
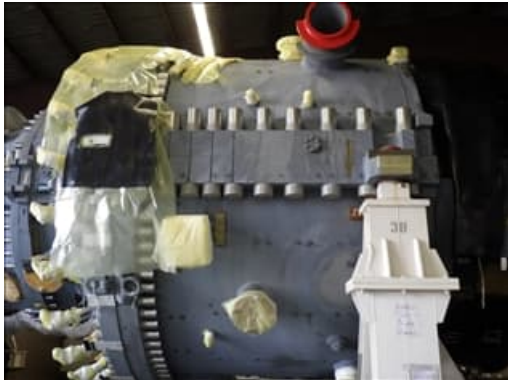
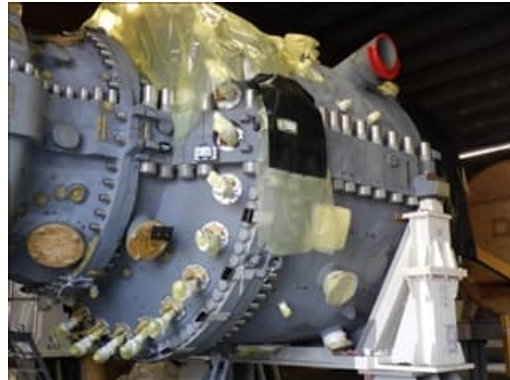
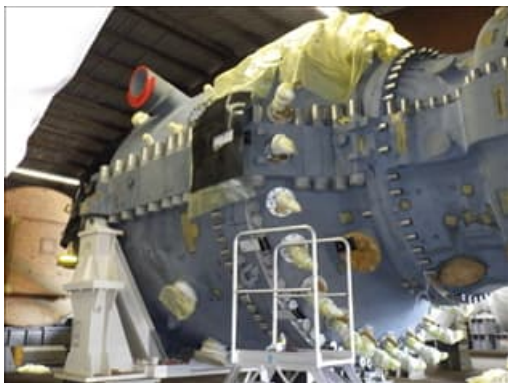
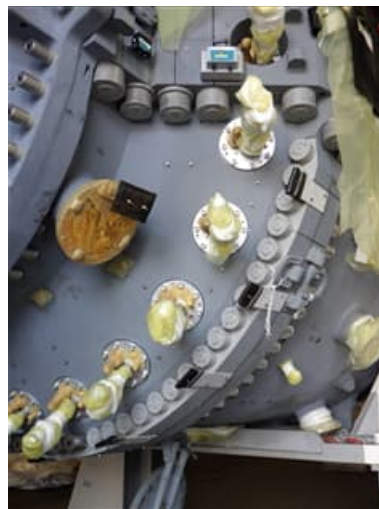
The Compressor casing Surface, the IGV and the IGV support roller were found in good condition, no sign of corrosion.

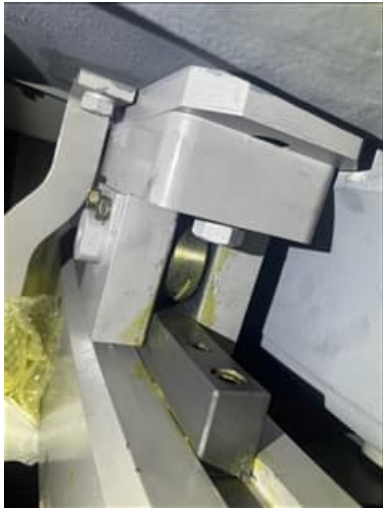
IGV support roller

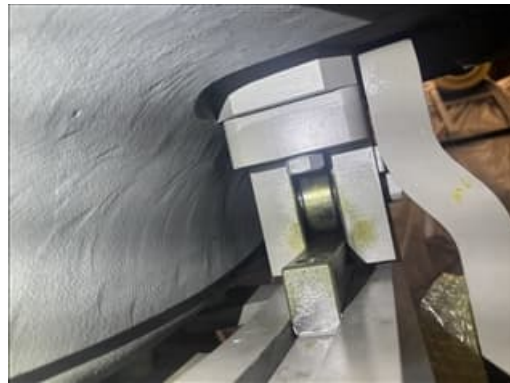
IGV support roller (1)

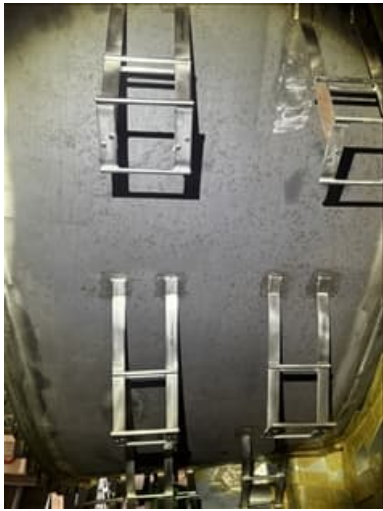
1. The turbine exit casing (TEC) exhibited signs of surface corrosion in several areas.
2. Two of the half joint bolts showed signs of paint loss and corrosion.

The turbine exit casing (TEC)

The findings can be left as found.

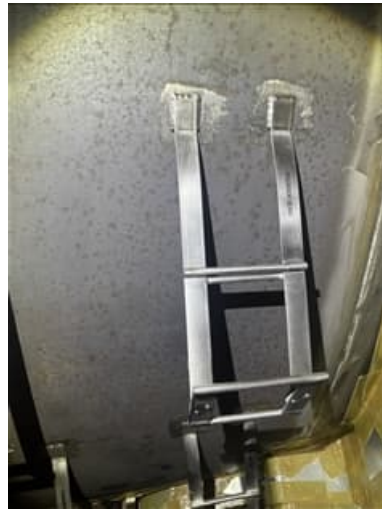
The turbine exit casing (TEC) (1)

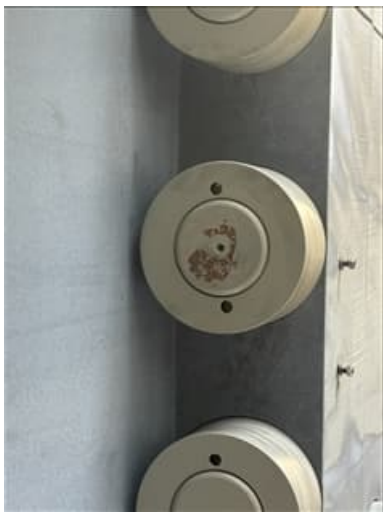
The half joint bolt

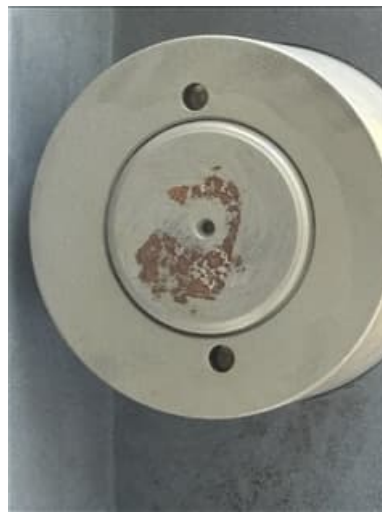
The half joint bolt (1)

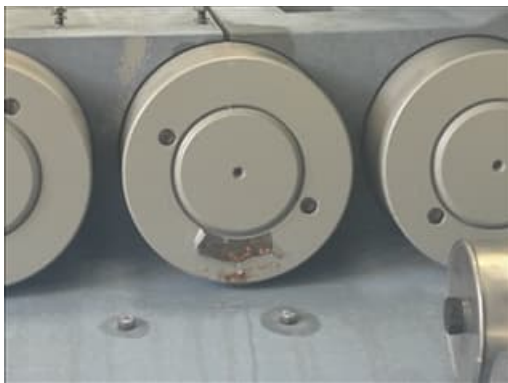
The half joint bolt (2)

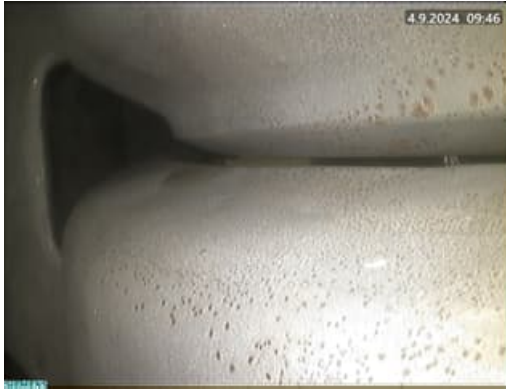
2409040054

The outer surface of the compressor vane carriers showed signs of corrosion. The pictures were taken from the access points to compressor stages #5, #9, and #13.

The finding can be left as found.

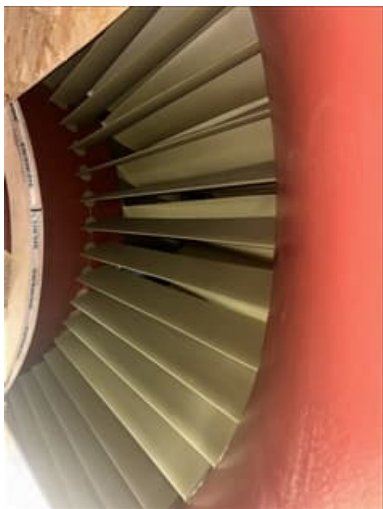
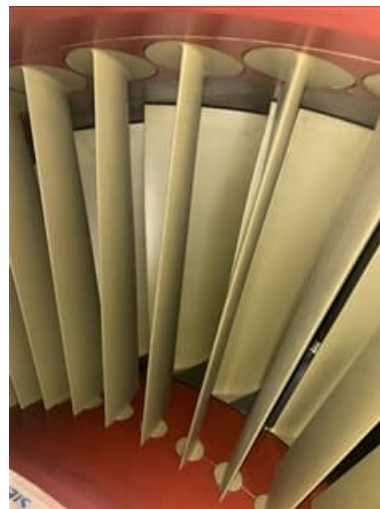
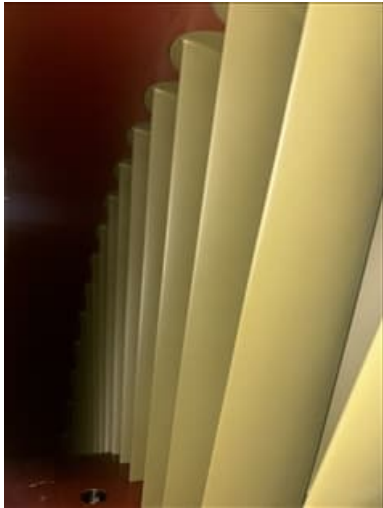
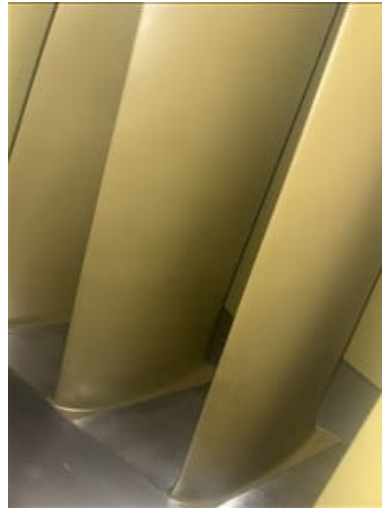
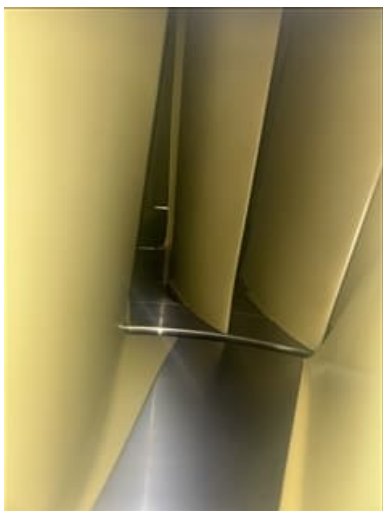
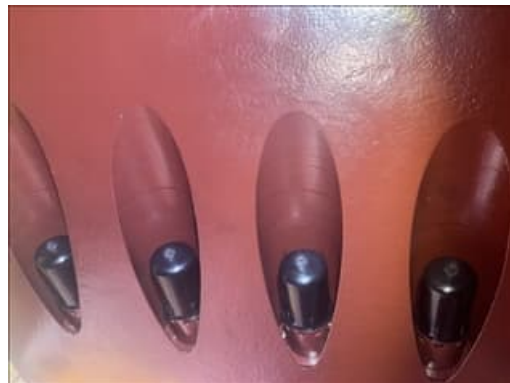
The compressor inlet area and the IGV region were assessed to be in good condition, with no indications of corrosion observed.

The findings can be left as they are, with ongoing monitoring to be conducted during future inspection.

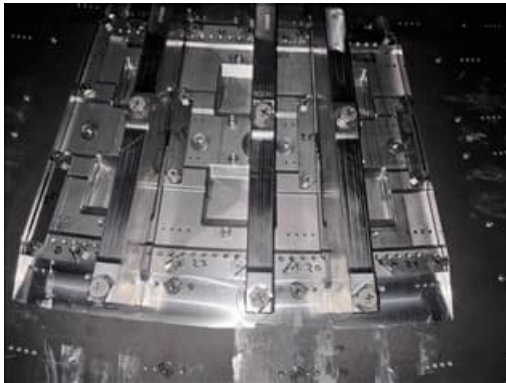
The lower outer manhole cover and the lower inner manhole connecting elements were found with a sign of corrosion.

The lower inner manhole

The finding can be left as found.

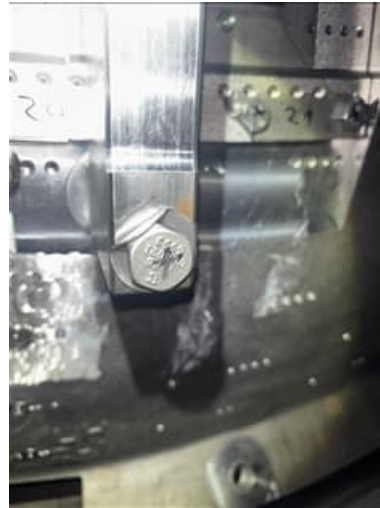
The lower inner manhole (1)

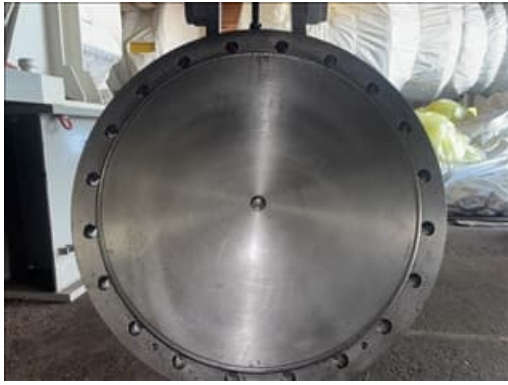
The lower outer manhole

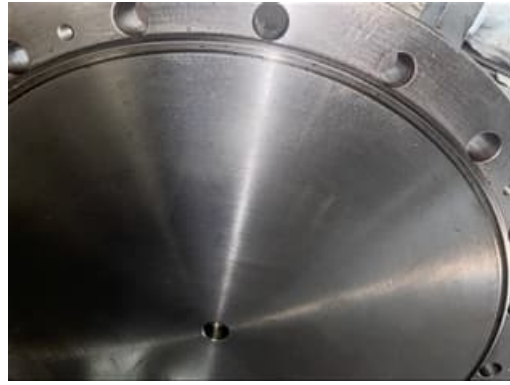
The lower outer manhole (1)

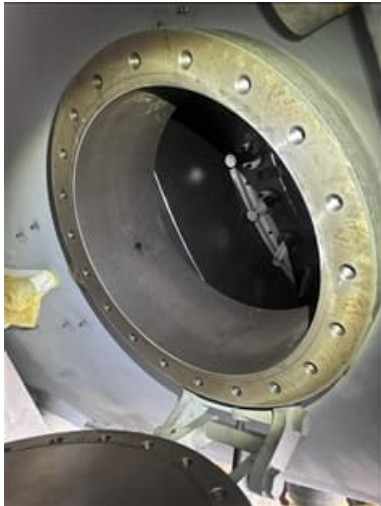
The lower outer manhole (2)

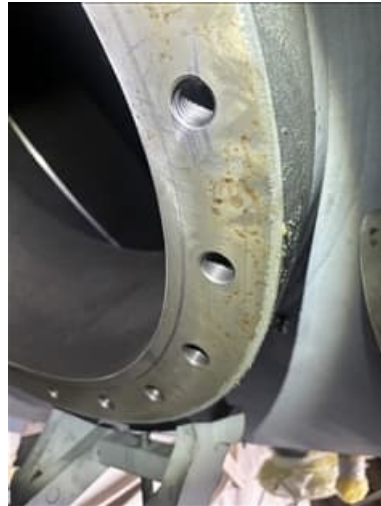
The lower outer manhole (3)

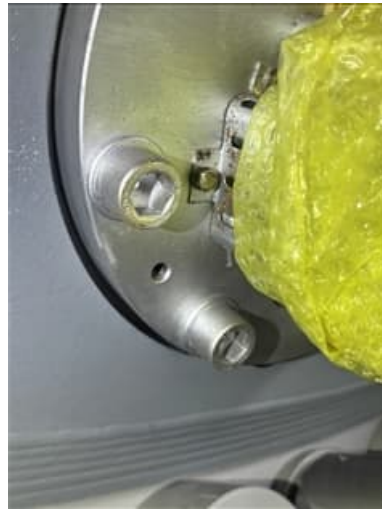
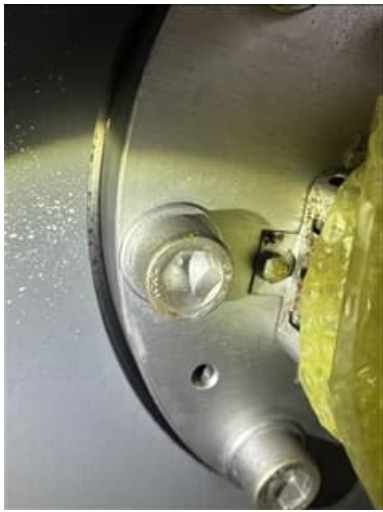
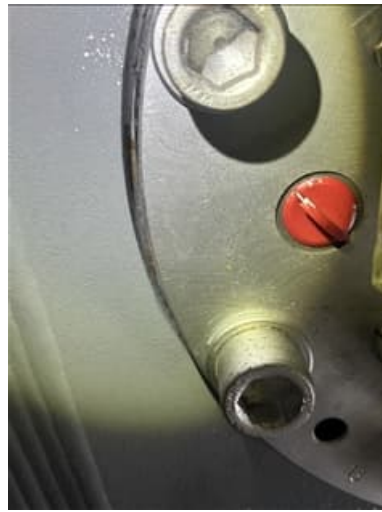
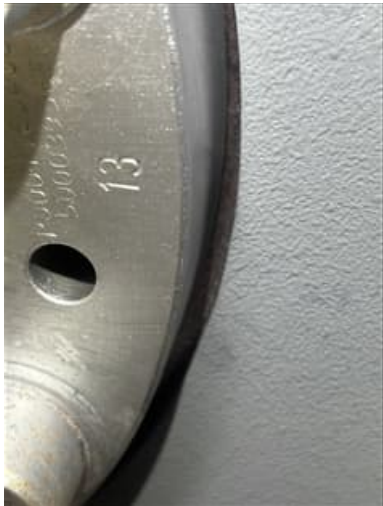
The burner supports were observed to have corrosion spots on their surfaces, particularly at the contact points with the casing and on the connecting elements.

The finding can be left as found.

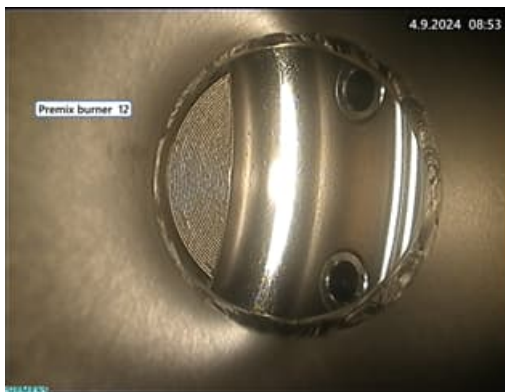
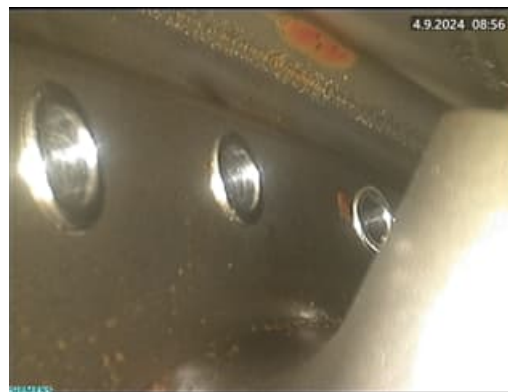
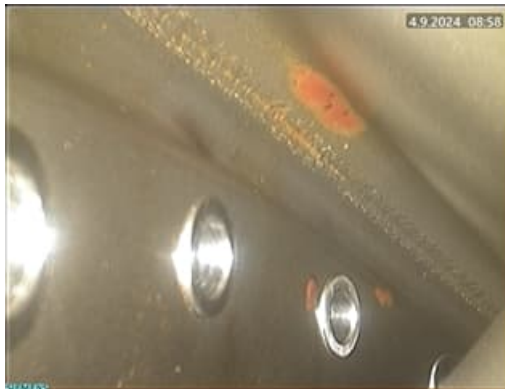
1. The burners displayed brownish/reddish deposits in the vane holes.
2. Slight corrosion was noted in the ring channel.
3. Very small droplets of water were found in inner channel of the burner #10.

The finding can be left as found.

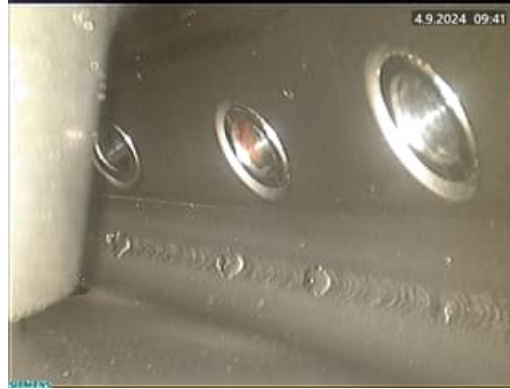
Burner #10 inner chanel with droplets of water
