**Special Inspection**

**CT-2022-0571**

Project: **POLO ENERGETICO ZARATE 23**

Shop Order No: **MB000169**

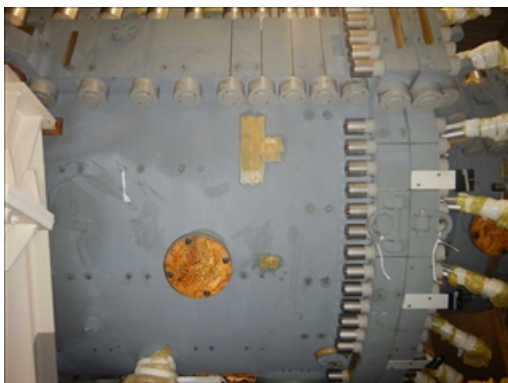
LHS turbine side

1. The turbine exit casing (TEC) was found with signs of surface corrosion on several spots.
2. One half joint bolt was found with painting loss and corrosion.

The findings can be left as found.

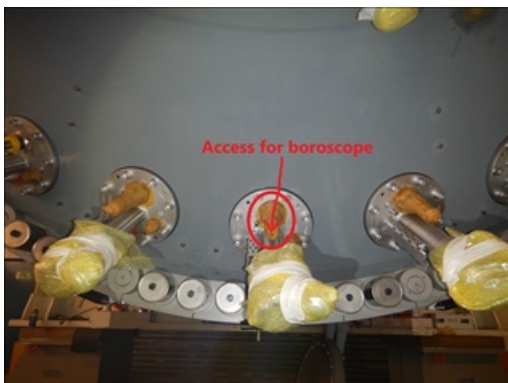
For the premix burner gas passage inspection the gas pipe connection was used as shown in picture "premix burner gas passage".

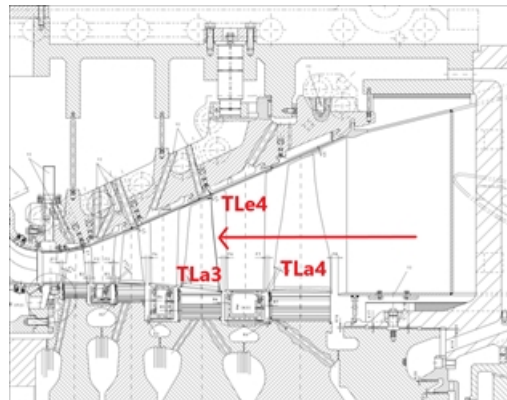
The turbine was inspected from the turbine exit casing as shown in picture "turbine".
