Fact Finding Report

Special Inspection

Project: **POLO ENERGETICO ZARATE 23**
 Shop Order No: **MB000169**
 Event ID: **NA**
 Period of Time: **2024-09-02 to 2024-09-05**

CT-2024-1425

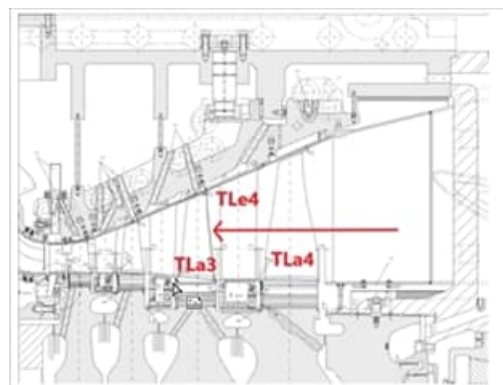
Turbine accessibilities

Additionally, the turbine inspection was performed through the turbine exit casing, illustrated in the image labeled "Turbine Accessibilities."

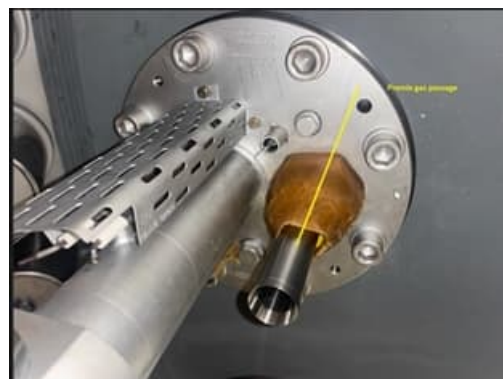
Premix gas passage burner #12

To inspect the gas passage of the premix burner, we accessed the gas pipe connection, as shown in the image titled "Premix Burner Gas Passage." A boroscope was used to inspect three premix burners: #10, #12, and #14.

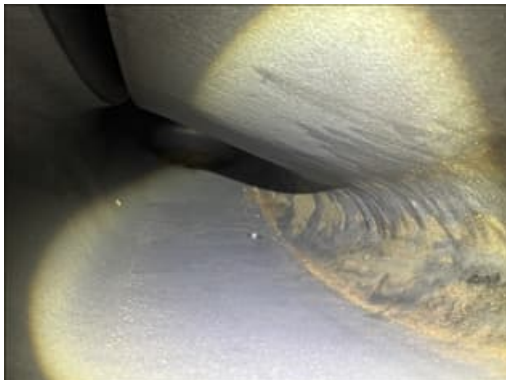
IMG_4927

The outer surface of the compressor vane carriers showed signs of corrosion. The pictures were taken from the access points to compressor stages #5, #9, and #13.

The finding can be left as found.

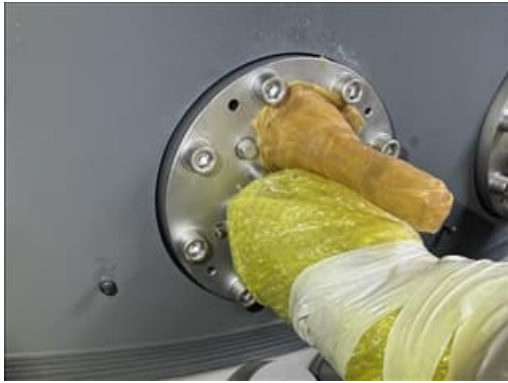
Burner overview

The burner supports were observed to have corrosion spots on their surfaces, particularly at the contact points with the casing and on the connecting elements.

The finding can be left as found.
